ARCHAEOLOGICAL INVESTIGATION OF A NINETEENTH CENTURY WATER FURROW IN CHURCH STREET, CENTRAL PRETORIA*

J.A. VAN SCHALKWYK, M. NAUDE & A.C. VAN VOLLENHOVEN

ABSTRACT

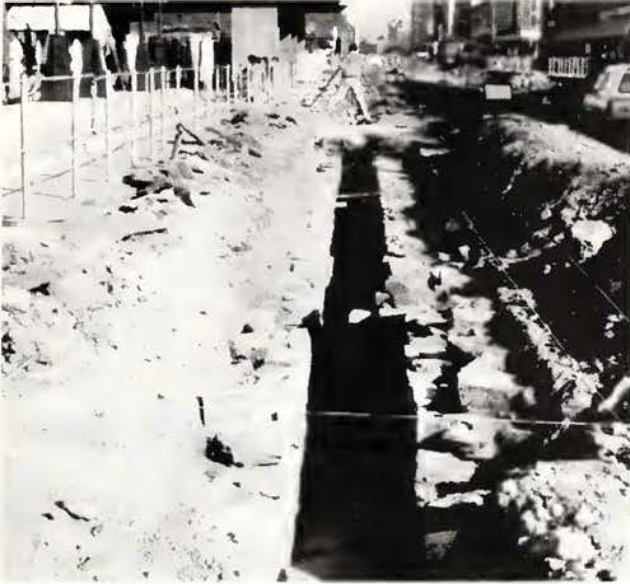
The contractor was asked to stop construction work around the feature in order to provide the archaeologist with the opportunity to examine the furrow (Fig. 1). There was a need for speedy completion of the excavation, due to the fact that the contractor was contractually bound to hand over the project at a predetermined date, failing which a financial penalty for each day would be imposed. The Museum was given five days to complete the investigation and to submit a written report. In the meantime, the contractor undertook to work on a different section of the project.

Fig. 1. The water furrow during excavation.

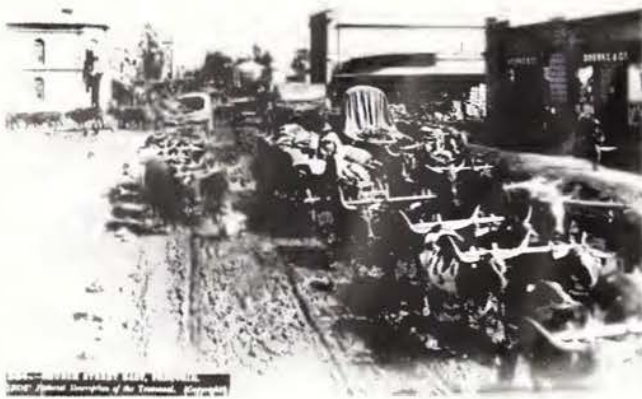
Fig. 3. Photograph of Church Street by H F Gros, showing the sidewalk over the furrow to the left.

seen as well as a curb (see the description in excavation 2 below) and a hole which might be the entrance to a drain. The same features can be seen on his photograph No. 384. It is thus possible that the furrow under discussion was located below the sidewalk (Fig. 3). The same can be said of photograph 20772 in the Transvaal Archives. On this photograph one can see what may be interpreted as inspection holes through the sidewalk. However, the overall quality of the photograph is not good enough to draw definite conclusions. Other photographs show that if the furrow were under the sidewalk it would, in time, have been covered by the stoep of the old Market building erected by 1879. The deduction made from this is that the furrow was built prior to 1879, *i.e.* before the map was drawn.

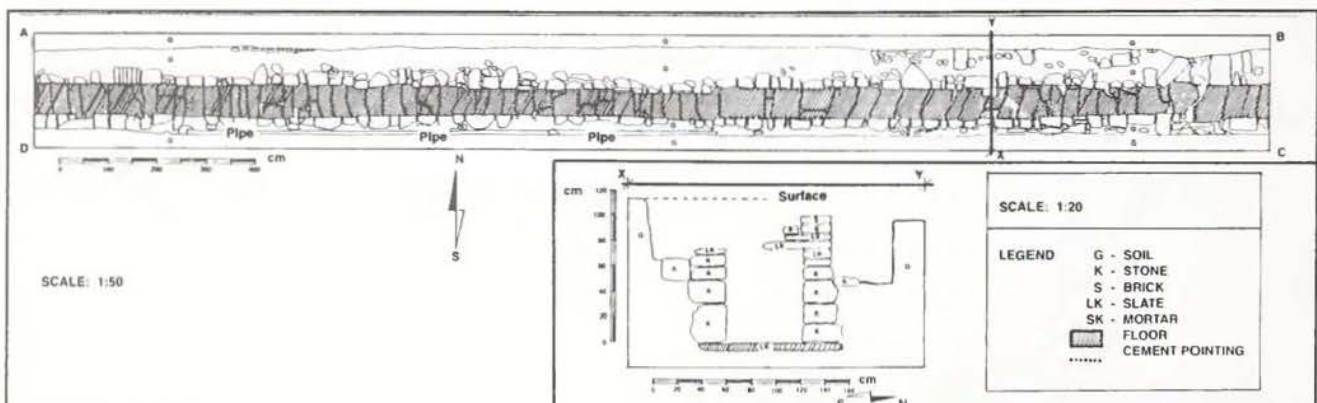
Excavation 1 (Fig. 4) consisted of a trench 25 x 2,3 m from east to west next to the entrance of the State Theatre. The purpose of this excavation was to establish the exact dimensions of the furrow as well as to gain

Fig. 4. Plan and section through the furrow, excavation No. 1.

After removal of the topsoil, *i.e.* approximately 0,5 m, the walls of the furrow became clearly visible. The deposit on the inside consisted mainly of soft silt that could be removed very easily. In places it included stones fallen from the roof and sides and pieces of concrete. All the material was removed down to the bottom of the furrow. Bottles, nails and other pieces of metal were recovered from the silt.

The occurrence of artefacts of recent origin, *e.g.* 2 litre plastic soft drink bottles, were possibly the most significant finds, indicating that the furrow has been exposed during recent times. This was later confirmed by people from the Water Department and Electricity Section of the Pretoria City Council who claimed to have found sections of furrows when installing services. A number of metal and plastic water and sewerage pipes found in the furrow provided further proof of this.

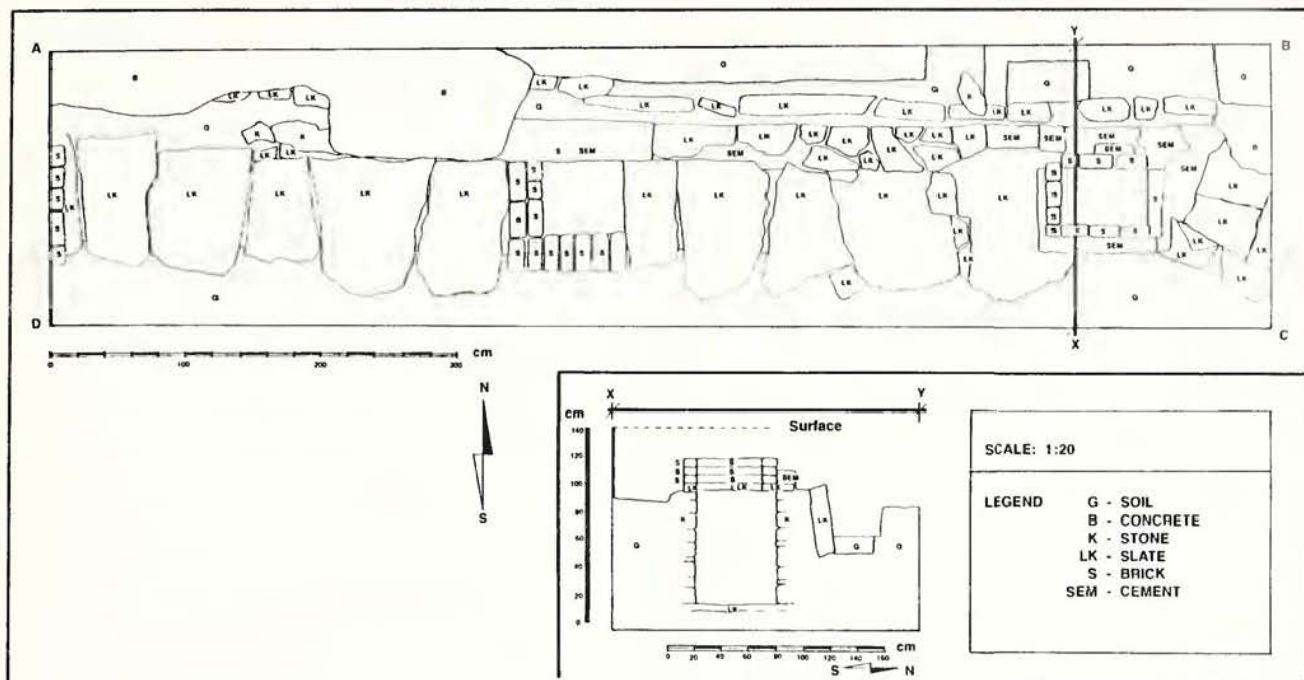
Fig. 5. Plan and section through the furrow, excavation No. 2.

Excavation 2 (Fig. 5) consisted of a block 9 x 2,25 m, close to the corner of Church and Van der Walt Streets which also runs in an east - west direction. In this area the furrow still had its original roof which also included two inspection holes. This section was investigated because it contained an undamaged section of the furrow. It was later decided not to remove the roofing from this section as it was one of the only sections where it was still intact and could be helpful in reconstruction of the furrow for exhibition purposes. Accordingly, this section of the furrow was excavated through the inspection holes.

Directly to the north of the furrow, in excavation 2, a line of rectangular stones was found. This seemed to

form part of the original curb stone structure. The stones were slightly higher than the roof of the water furrow. The excavation was extended over a further 2 m section to establish the significance of these stones. It was also explored downwards to establish the connection of these stones with the original roadbed (if the latter still existed).

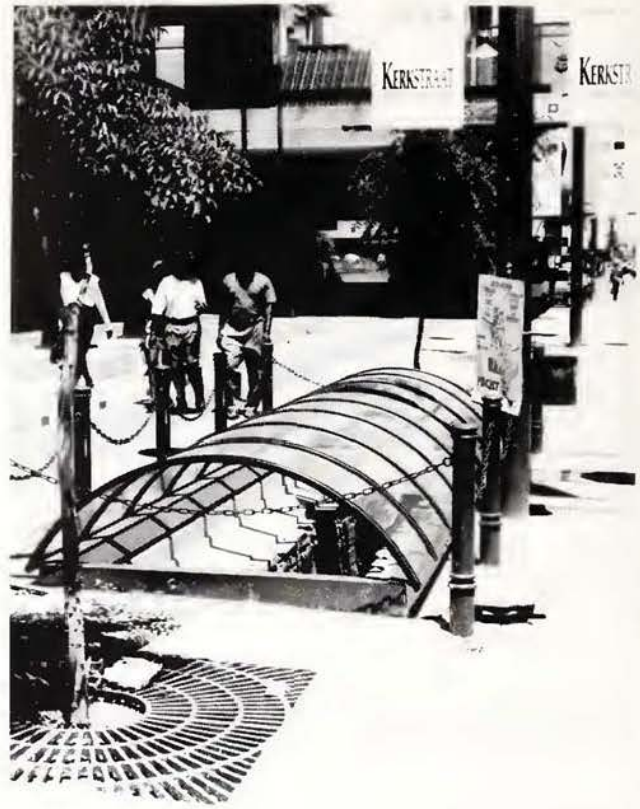
Fig. 6. Reconstruction of the furrow for public viewing.

preventing situations such as the one described in this paper arising. It is therefore believed that the decision made by the City Council to reconstruct a section of the furrow for public viewing (Fig. 6) will make people aware as to the importance of cultural resources and thereby increase the likelihood of receiving their cooperation in the future.
