# KLEIN GANNAHOEK: AN ARCHAEO-ARCHITECTURAL INVESTIGATION OF AN AFRICAN FARMHOUSE\*

## ABSTRACT

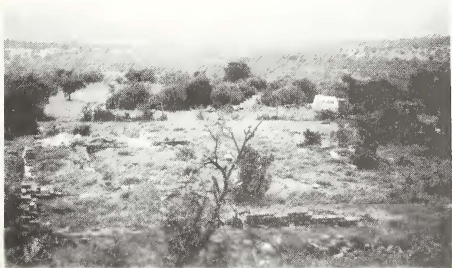
Fig. 2. Klein Gannahoek farm site.

The site was very overgrown and had to be cleared to reveal the general structure of the homestead. No complete walls are standing and the only really visible features are some stone foundations and steps (Fig. 2). The remains of a small brick wall, some foundations, three sets of stone stairs and broken stone-wall foundations that support a stone-flagged 'stoep' were visible before cleaning (Fig. 3).

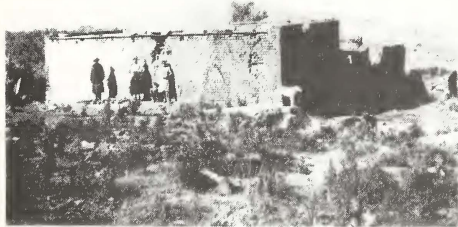
Fig. 8. Photograph taken by Cronwright-Schreiner on 13 June 1921 with the inscription; "The same house, northern aspect (facing the mountain). The window of Olive's room was where the coloured girl dressed in white is standing. Compare this photo with that taken by me in 1893 before the house was in ruins. Note the spot where the oven was in the wall on the right. Here Olive began *The Story of an African Farm*" (Photograph NELM).

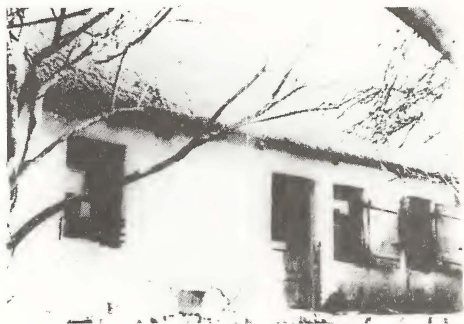
Fig. 10. Klein Gannahoek farmhouse front 'stoep' (Photograph University of Cape Town Libraries).

The house at Klein Gannahoek later had its mono-pitched roof removed and replaced by a double-pitched roof (Figs. 12c & e; 7, 10 & 11). The photographs show a thatched double-pitched roof over the livingrooms or bedrooms. A loft is distinctly visible on the north side of the homestead. At either end of the thatched roof is a gable wall. The type of thatch used was possibly a local grass that still exists around the farm

No trace of the windows is left on the present site. However, four photographs show the type of windows used in the building (Figs. 7, 10 & 11). Three different windows can be identified, namely, sliding sash-windows, single casement windows and a single shutter window. Alterations to the window positions which had been made at various times can be seen in photographs (Fig. 8 & 9). The northern back-wall windows were all bricked up and plastered over by Richard Cawood when he converted the house into a goat shed. Another window was converted to a doorway.

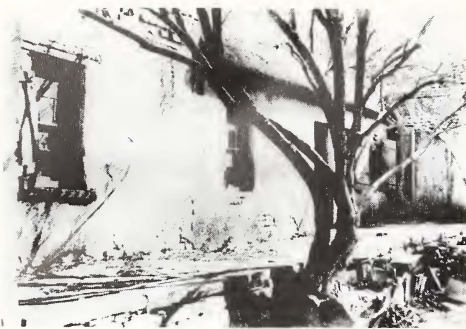
Fig. 11. Klein Gannahoek farmhouse front 'stoep' looking north (Photograph Cradock Public Library).

The evidence for a southern lean-to roof over what was possibly the stoepkamer is suggested by the Cradock Public Library photograph (Fig. 11). A structure that looks like the extension wall of the purported 'stoepkamer' is clearly seen branching out from the gable wall which supports the double-pitched roof. An elevation of the outer corner wall of the 'stoepkamer' is clearly seen in the photograph.

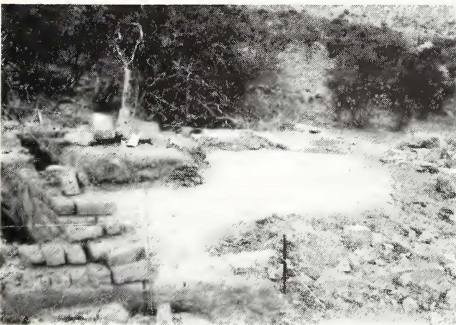
The floors are made of a mud/clay substance mixed with cow dung. Three earth floors were located. The core of the earth floor was 140 mm thick compacted fine-grain soil. The present layer of dung floor is approximately 35 mm thick (Fig. 13).

Fig. 13. Exposed dung floor and brick wall.

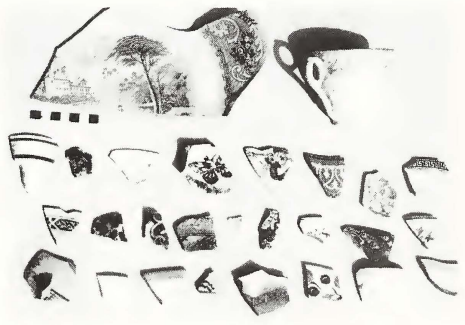
Artefacts were scattered over a large area and were collected on the surface during the course of the investigation. These consisted of very small broken pieces of pottery, glassware, wood and metal. A few small ceramic items were found and collected in the test trenches (Fig. 14). Among the ceramic finds were three fragments of a flat-topped lid. These were once part of

Fig. 14. Designs on the ceramics found at the site.

a square pot container used for toothpaste sold under the commercial name White Rose Paste, marketed by S. Man, Son & Sons, Aldersgate, London. The pot lids

were used from about 1860 to about 1910. The design is in monochrome black with underglazed printing (Lastovica 1982:70).

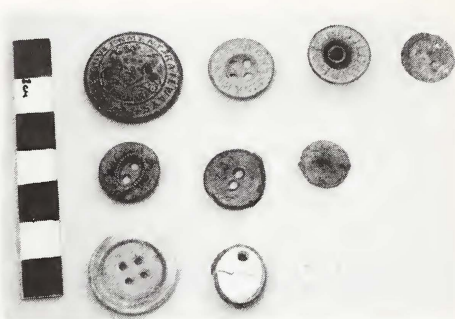
Ten buttons of various sizes were found. One button was made of pearl embedded in a bronze jacket (Fig. 15). The largest brass button found belonged to a railway tunic. It had the Union coat of arms embossed on it.

Fig. 15. Selection of buttons found on the site.

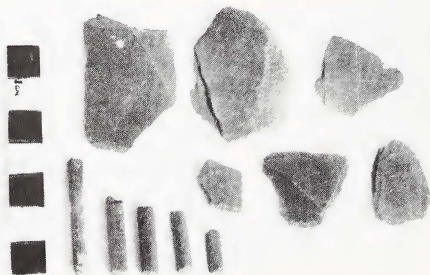
Some slate stone and slate pencil shards were located. These were found near what is believed to have been the room which Olive Schreiner occupied at Klein Gannahoek. Five slate pencil shards and five pieces of slate were uncovered (Fig. 16).

Fig. 16. Slate stone and pencils located on the site.
