# AN HISTORICAL ARCHAEOLOGICAL INVESTIGATION OF FORT DASPOORTRAND, PRETORIA\*

ANTON C. VAN VOLLENHOVEN

*National Cultural History Museum,  
P O Box 28088, Sunnyside, 0132*

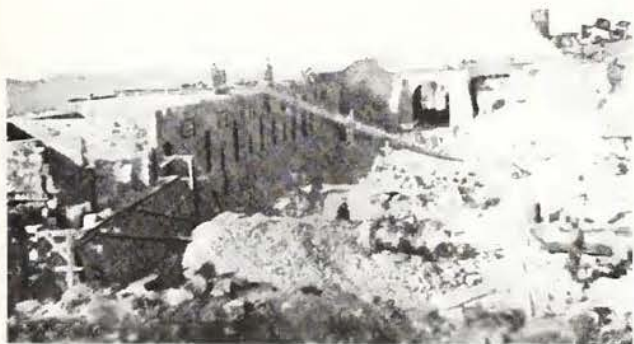
Fig. 3. Fort Daspoortrand under construction (T.E. Andrews Collection).

Fort Daspoortrand was built west of Pretoria, on the Daspoortrand, with a good view over the surrounding territory (Fig. 1). It differs from the other three, having been built by Grunberg, thus in French style (Transvaal Archives KG 255 Cr 3928/99:17) (Fig. 2). Grunberg had complained to the commander-general of the ZAR, P.J. Joubert, about not getting the contract to build the forts and was in consequence awarded responsibility for this fort. (Ploeger 1968:35) (Fig. 3).

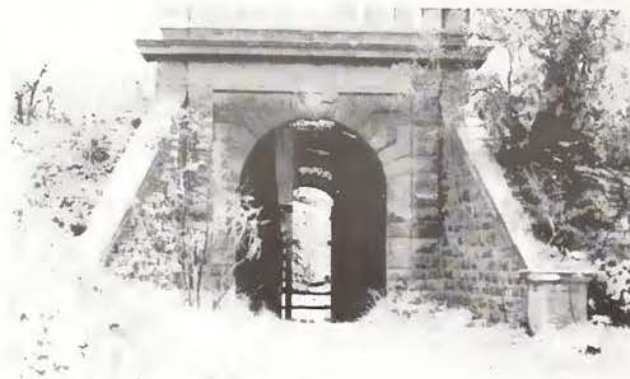
feature of the fort is its entrance which features two sets of steel doors and five arches (Fig. 5). It also contains three ammunition rooms, partly underground, connected by tunnels as well as two lifts, for supplying ammunition to the guns on the bastions of the fort. The functions of some of the rooms are still indicated above the doors in the original Dutch e.g. keuken (kitchen), telegraaf (telegraph) and machinen (machine) (Fig. 6). Apart from the roof having fallen in, the fort is reasonably well preserved. However erosion of the earthen walls and vandalism are threatening the structure (Fig. 7).

Fig. 5. The entrance to Fort Daspoortrand.

In the first section a 0,20 m thick layer of earth had to be removed to reach the approximated floor level which was estimated from a sump in the entrance complex. It is presumed that it was a earthen floor, similar to that of the other three forts (Transvaal Archives, F385; Cape Archives, Elliot collection 3502). Below this, on the eastern side of the entrance, a threshold was found. It consisted of a row of dressed stones with a steel bar across it. At the southern side a step, door and window, leading to a room (probably a guard room) were found. At the western side another threshold was located. This was made of cement, sided by iron bars, probably to tie horses.

The next section was sealed off from the first by a second pair of steel doors. A tunnel connecting the inner part of the entrance with the machine room was also found. As a result of the danger presented by large cement blocks which could collapse, the inner sections of the entrance were excavated by means of a back actor. As no stratigraphy existed this material could be removed as a single unit. It also led to quick results (South 1977:303). The loads of rubble were carefully monitored for artefacts.

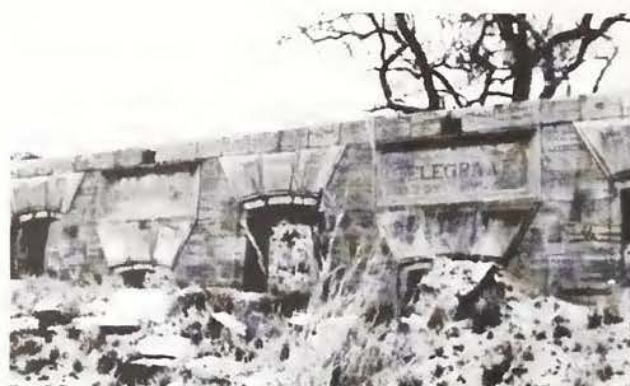
Fig. 6. The names of the casemates are still legible.

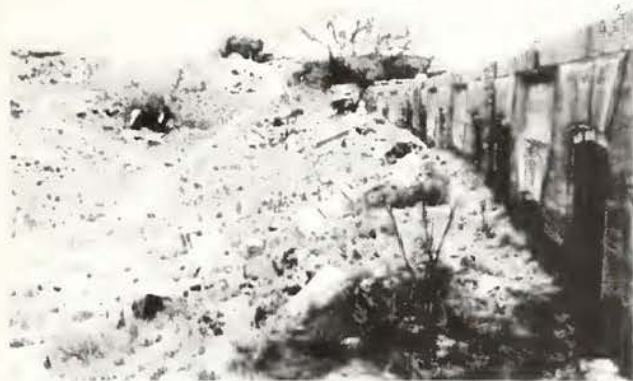
Fig. 7. The current state of Fort Daspoortrand.

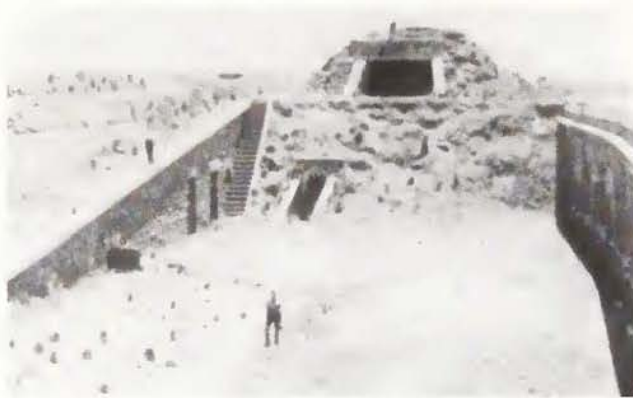
Although the fort was only partially excavated a clear picture of its plan emerged. In addition, valuable information was obtained from archival photographs, some of them showing structures such as the underground water reservoir and two as yet unidentified rooms (Fig. 8). These latter require further archaeological investigation.

Fig. 8. Photograph, taken in 1913, of the western side of the fort. It shows a similar entrance to that of the water reservoir at Fort Klapperkop, as well as the entrances to two other rooms. (Transvaal Archives photograph 20910).
