REPORT ON FINDS AT THE VICTORIA AND ALFRED WATERFRONT, CAPE TOWN, BETWEEN 1990-1993*

G. ABRAHAMS-WILLIS

*Department of Archaeology,
South African Cultural History Museum,
P.O. Box 645, Cape Town 8000*

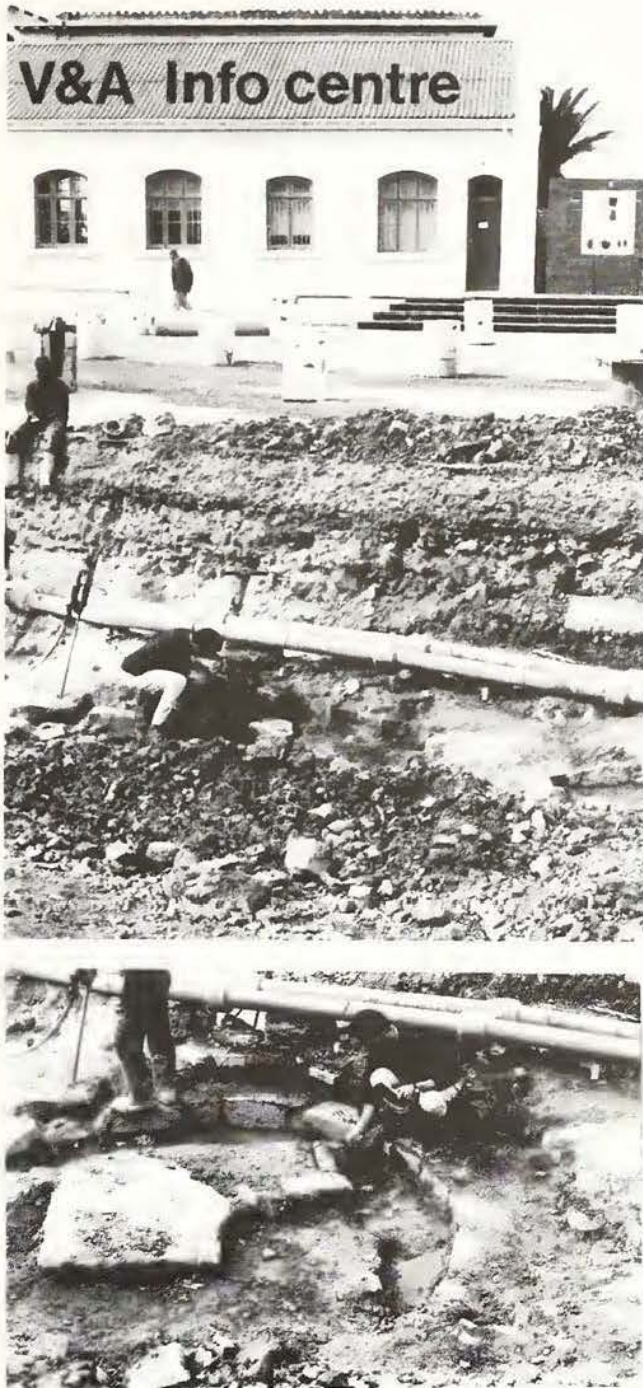
Fig. 2. Photographs depicting the feature uncovered in front of the Information Centre.

in the area opposite the present Information Centre (Figs 1a, 2). No associated artefacts were found with this fountain or ornamental-type feature and the area was largely disturbed by previous and contemporary pipe and cable-laying activities.

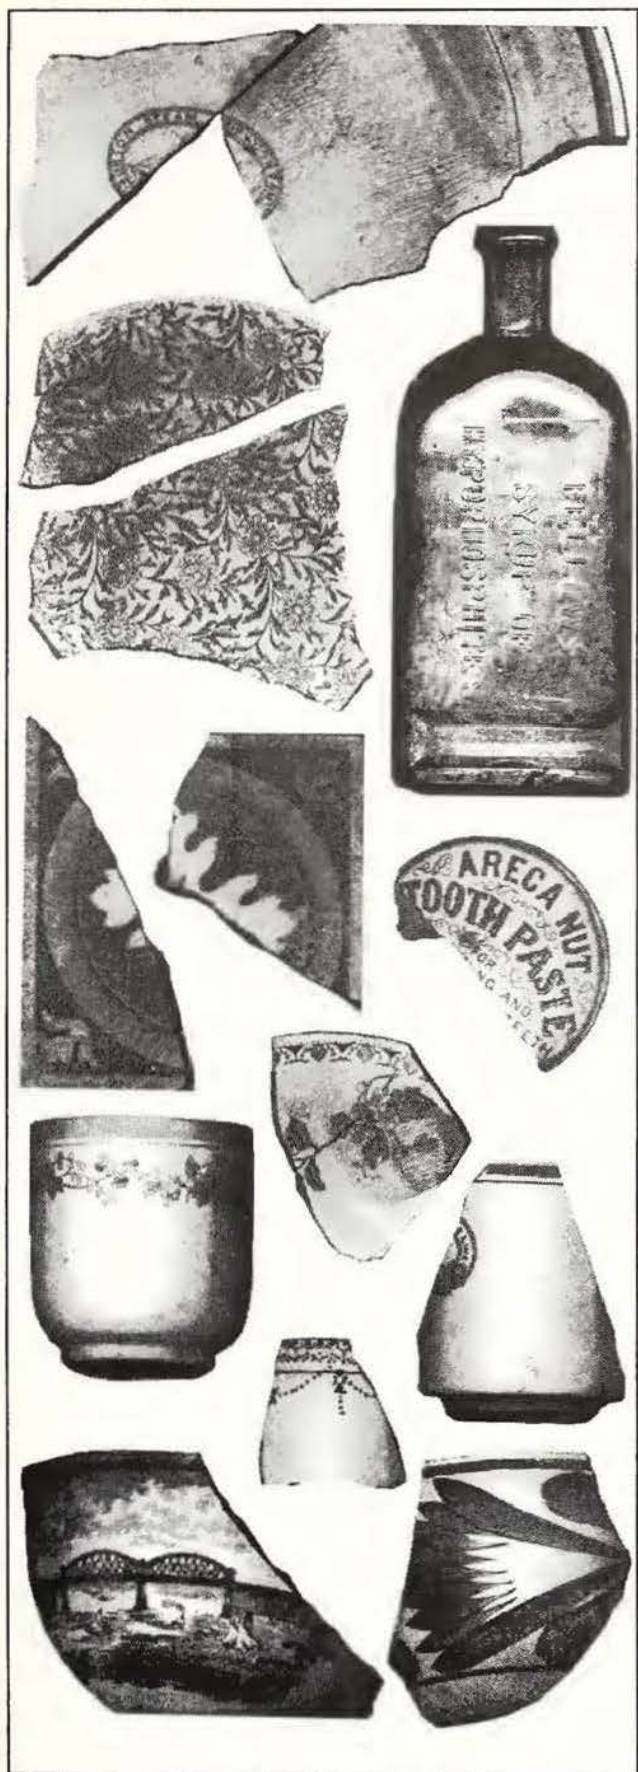
Fig. 5. A random selection of artefacts of the 19th and 20th centuries uncovered in the vicinity of the present Victoria Wharf before it was constructed.

During developments by the V&A Waterfront Company between 6-21 September 1990, an iron jetty and a breakwater feature were located in the area forming the present basement parking of the Victoria Wharf Retail and Development Centre (Fig. 1b, 1c). This site was once part of the early Dockland Development and, according to maps of the area (Cape Town City Council, Land Survey Branch Map dated c. 1884; Cape Archives M1/2454; Regional Engineer of Harbours, Table Bay Historical Development Plan 1985), this section was developed sometime between 1870-1920, both features pre-dating at the least around 1885. The jetty was constructed on a base of stones/cobbles which formed a platform on which iron boxes filled with stones and cement were placed (Fig. 3). Figure 4 is a measured drawing of this feature. The iron boxes themselves were riveted and in certain places where the iron boxes were missing, the gaps of equal size were filled with concrete contained on the outside by planks nailed across the boxes. In the vicinity, hundreds of artefacts were salvaged (Fig. 5).

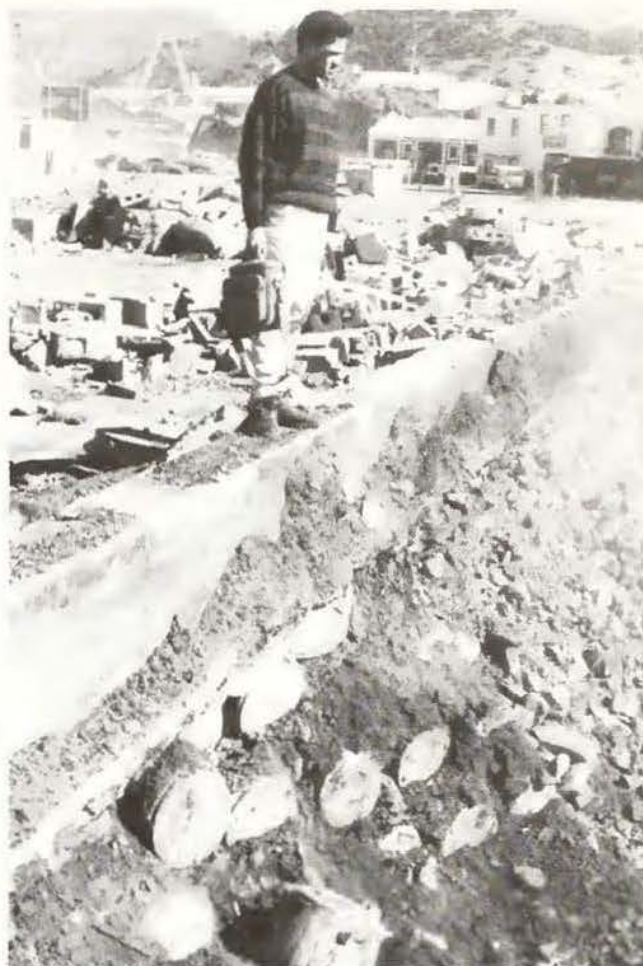
The breakwater feature was uncovered in close proximity to the jetty (Fig. 1c). It was constructed with what appeared to be quarried stone mixed with clay contained, at one end, with cast concrete barrels (Fig. 6). A short distance away, there was a small island in the road (Fig. 1d) which had a plaque marking the site of the original breakwater. It read,

The area between the breakwater feature and the jetty was filled with quarried stone and yellow clay, cobbles and rubble. The fill contained artefacts dating mostly from the latter part of the 19th century onwards, the period post-dating the construction of the original breakwater. The indications are that like the jetty, this was part of the docklands development which took place after 1870, but before 1884, alongside the original breakwater of 1860 (Regional Engineer of Harbours, Table Bay Historical Development Plan 1985).

Fig. 6. Photograph depicting A part of the breakwater feature, constructed in one section of concrete barrels and filled with stone and yellow clay at the other end.
