## **REASSESSING THE EXCAVATION OF THE CHURCH STREET WATER FURROW, PRETORIA, BY MAKING USE OF HISTORICAL SOURCES**

**ANTON C. VAN VOLLENHOVEN**

The results of the excavation of a water furrow, discovered in central Pretoria during 1994, were published in a previous issue of *South African Field Archaeology*. However these were not complete, mainly because of the time constraints placed on the researchers, as it was a rescue excavation. Only a selection of historical sources were used to obtain information on the site. In this article, the information regarding the furrow is expanded and reassessed in order to determine the correct date and function thereof. All available historical sources were critically compared in order to assess their reliability and accuracy.

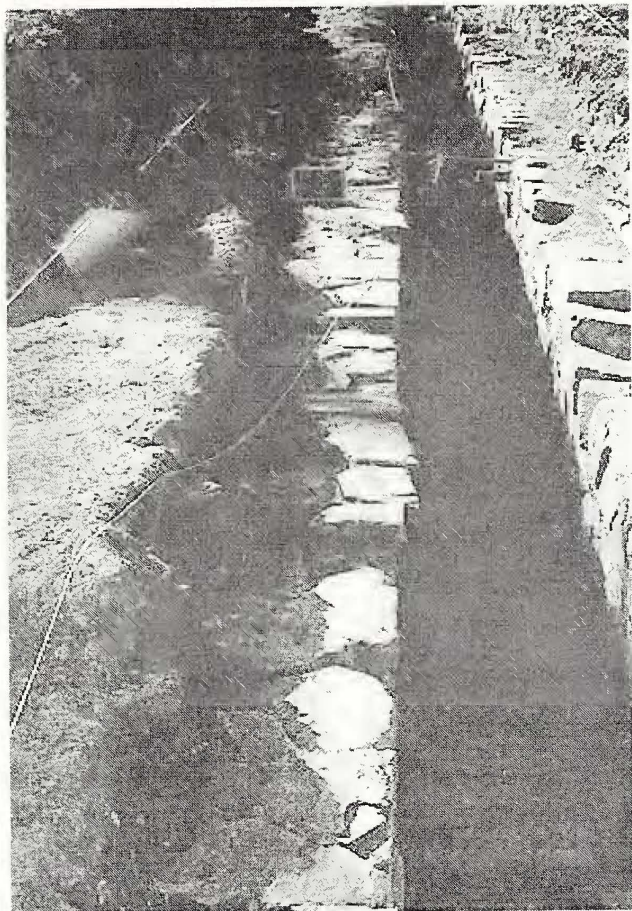
**Fig. 2. The completed excavation 1 showing the furrow (Photograph by F.E. Dreyer).**

A full description of the site was given when the results of the excavations were published (Van Schalkwyk *et al.* 1995:78-79). Therefore only a photograph of the furrow is included to show what it look like (Fig. 2). It is also sufficient to say that since the founding of Pretoria in 1855, the area has been subject to continual change owing to urban development.

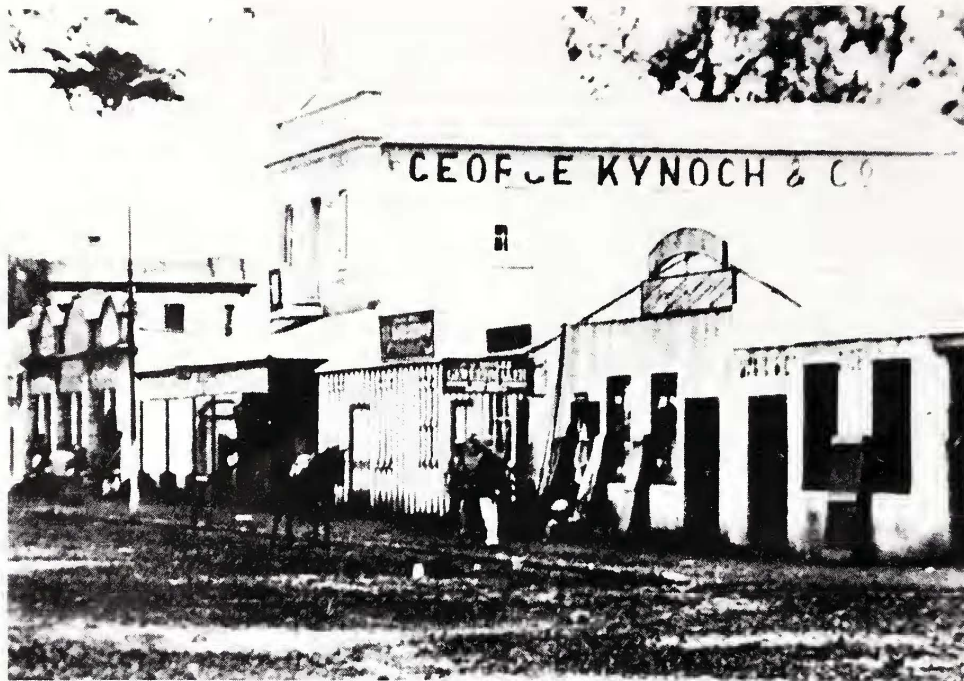
**Fig. 3.** This photograph from 1890 shows an open water furrow on the northern side of Church Street East (Dunston 1975:154).

A photograph dating from the period before 1889 and a photo from 1890, show an open furrow on the northern side of the street (Dunston 1975:73-74, 154-155). This feature is in line with the hypothesis that the furrows had to provide water for the block of erven lower down the incline, that is to its north (Fig. 3). Photographs from the period 1890-1894, show no signs of a furrow (Dunston 1975:74-75, 122). A photograph taken by Gros, dated 1889, shows no sign of a furrow on the southern side of Church Street East (Dunston 1975:132), another of the same area dated between 1889 and 1904, also shows no furrow or water inlet at this spot (Fig. 4) (Dunston 1975:134-135), and nor do the rest (Dunston 1975:124-127). A photograph dated 1894-1895 does show a sidewalk and kerbstone with a

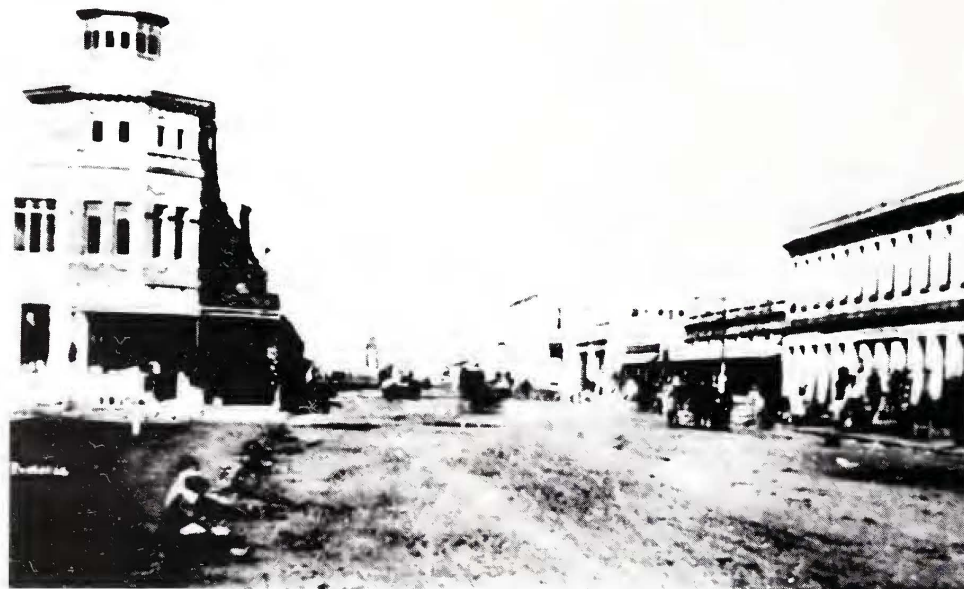
**Fig. 4.** This photograph, dated between 1889 and 1892, shows no furrow or water inlet in the sidewalk on the southern side of Church Street East (Dunston 1975:135).

water inlet on the southern side of Church Street East (Fig. 5) (Dunston 1975:90-92). This demonstrates that a water furrow with a cover (roof) already existed at that time and that the date of Figure 4 is more probably between 1889 and 1892. Together with previous deductions this means that this furrow on the southern side of Church Street East must have been built between 1892 and 1894. It is shown on a photograph dating from 1903 (Dunston 1975:100-101). The market building was completed around 1891-1892 (Dunston 1975:144). It was built on the southern corner of Church and Van der Walt Streets, in other words, in the area under investigation. A poor quality photograph from 1892 of this area shows a kerbstone, but no water inlet (Fig. 6) (Dunston 1975:152-153). Since the sidewalk stretched over the furrow at about 1892 in the area being investigated, it may be assumed that the furrow was most probably built in 1892 - before the sidewalk and stoep (veranda) of the Market building extended over the furrow (Dunston 1975:135).

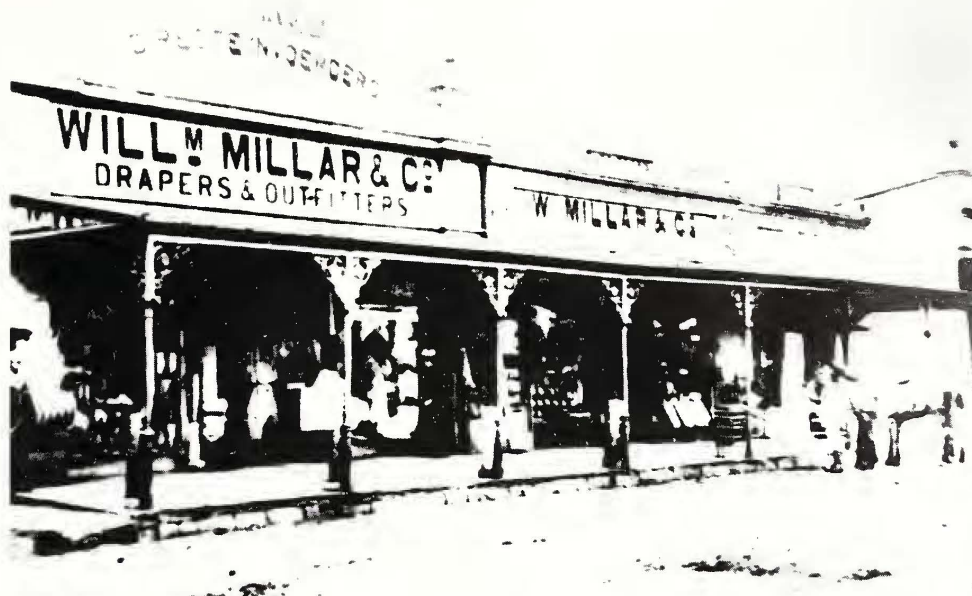
Fig. 5. The southern side of Church Street East from 1894/5. A water inlet is clearly visible in the sidewalk on the left hand side. This is the street block just east of the area under investigation, *i.e.* between Andries and Van der Walt Streets (Dunston:1975:90).

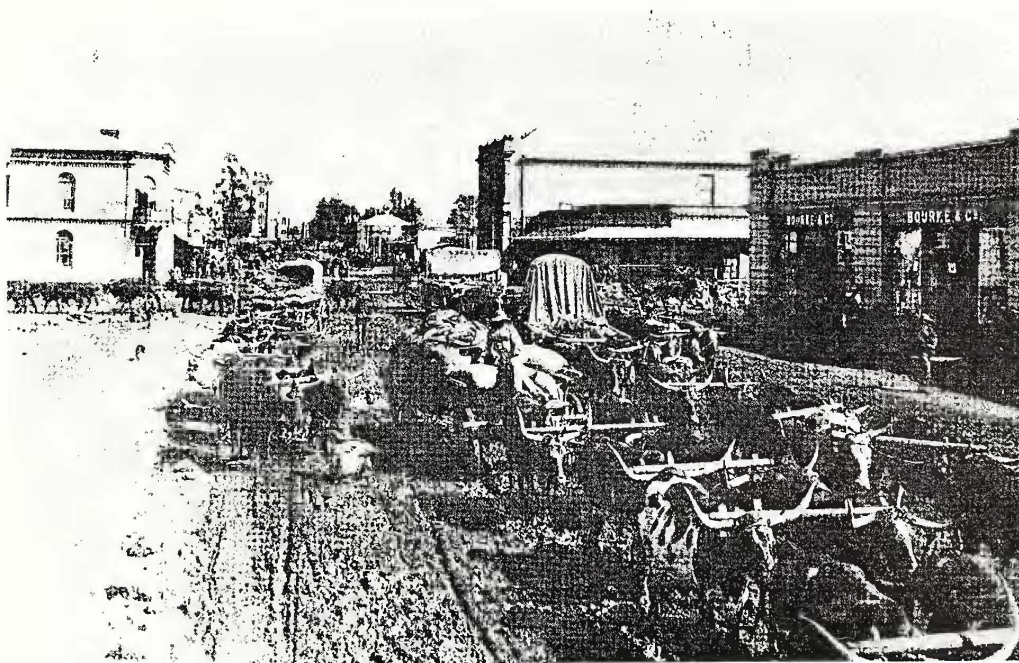
Fig. 6. This photograph, of the area under investigation from 1892, shows a kerbstone but without any water inlet (Dunston 1975:153).

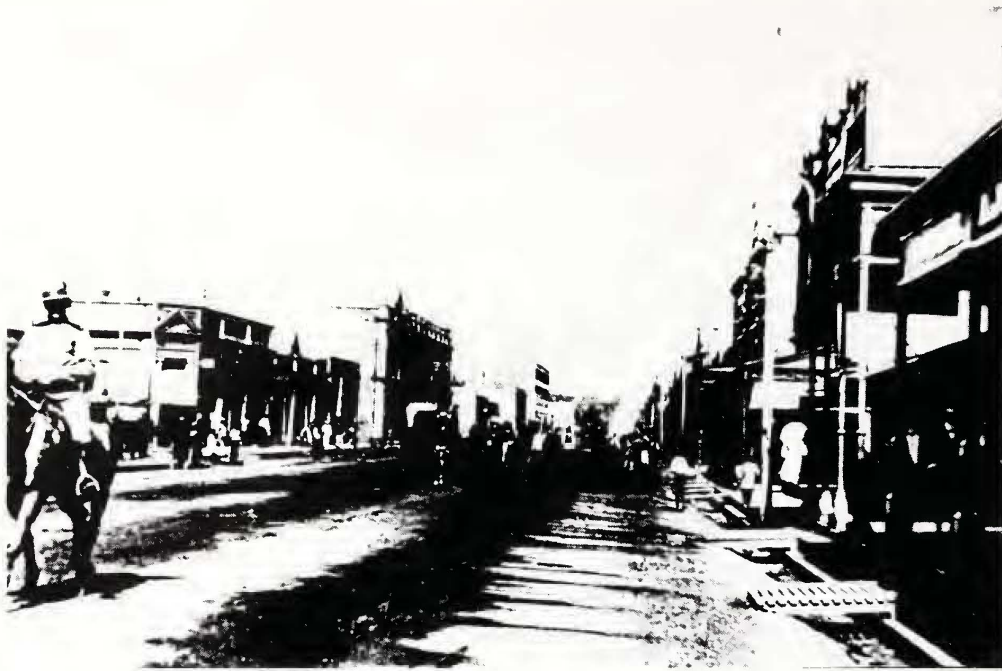
**Fig. 7.** A photograph of Church Street East in 1904. The function of the shallow furrow on the southern side (on the right) next to the kerbstone, was to drain storm water to inlets in the sidewalk. The photo indicates that the furrow under investigation was still used in 1904 and that it was a stormwater ditch (Dunston 1975:141).

A photograph from 1904 of Church Street East between Andries and Van der Walt Streets shows a shallow 'furrow' against the kerbstone of the sidewalk on the southern side of the street (Fig. 7) (Dunston 1975:140-141). This is a small furrow with the purpose of quickly taking away storm water to the water inlets against the kerbstone. From here the water flows to a furrow, or storm water ditch, under the sidewalk. The photograph proves that the furrow that was investigated was still in use in 1904, and that it was nothing more than a storm water ditch.

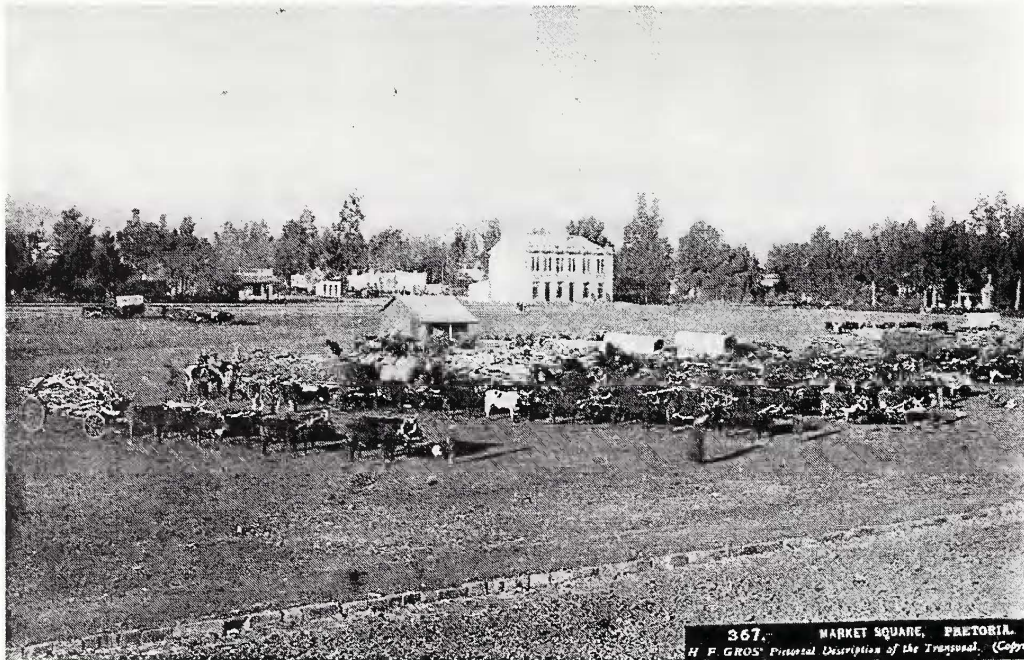
**Fig. 8.** This photograph clearly shows a water inlet in the kerbstone (bottom left) at the investigated area (Gros n.d.:367).

One of the best photographs, indicating the possible existence of the water furrow, is Gros's photograph no. 367 of the Market Square (Fig. 8). On this the well-defined sidewalk, as well as the kerbstone can be seen. A hole in the kerbstone is clearly an inlet for water (Van Schalkwyk *et al.* 1994:7). Unfortunately, the photograph is not dated precisely, but on the grounds of the above evidence it is clear that it was taken only after 1892.

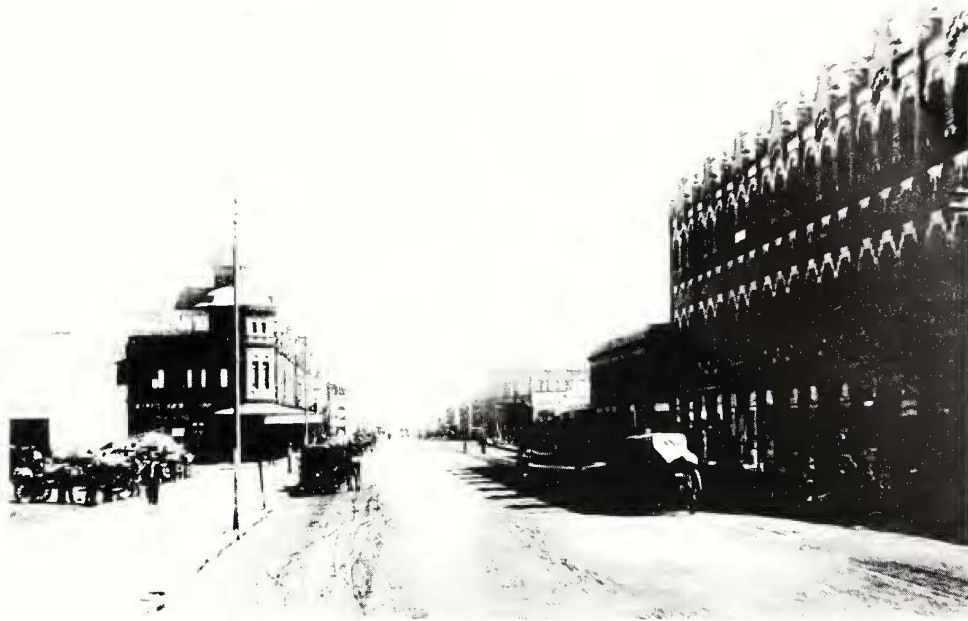
**Fig. 9. This photograph shows manholes in the sidewalk (left) at the investigated area. It dates from 1906-1910 and proves that the furrow was still in use during this time (NAB, 20 772).**

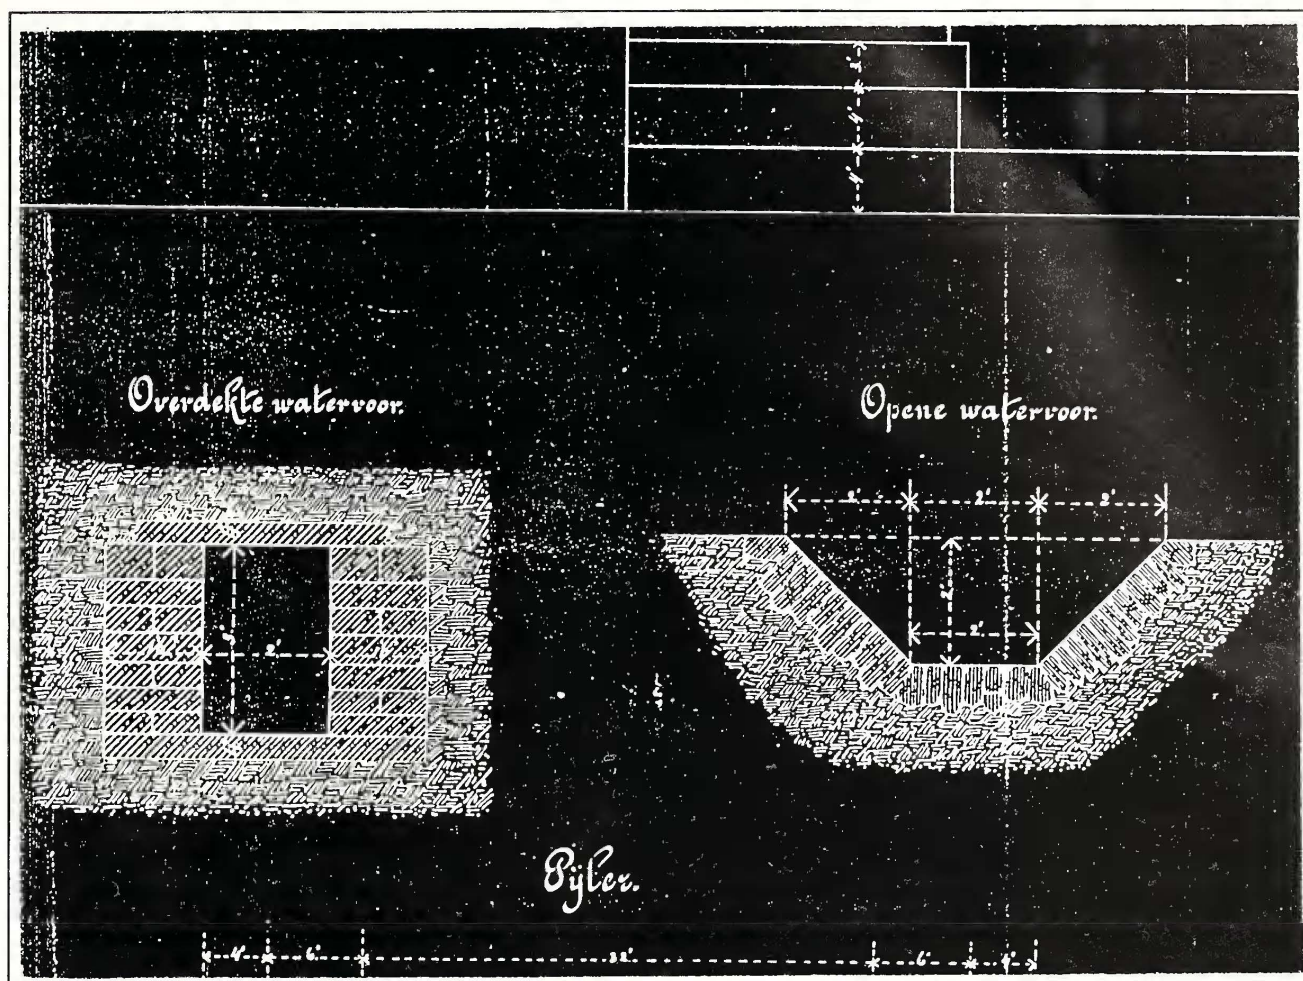
Fig. 10. A drawing by the State Architect S Wierda from 1893: plans for open and covered water furrows in Pretoria (NAB, S2/109).

An architectural drawing from 1893, by the state architect S. Wierda, shows plans for open and covered water furrows (Fig.10) (NAB, S2/109). This indicates that water furrows were still being planned in Pretoria during the early 1890s. However, for the purposes of this study the evidence about covered furrows is more important. The measurements of the covered furrow on the plan were more or less the same as that of the furrow under investigation (see Table 1). This indicates that the excavated furrow was most probably built during the early 1890s. It is known further that open and covered drainage and water furrows were built in Pretoria in 1898 (NAB, ZAR 97:129; Peacock 1955:187).
